NATIONAL DAM INSPECTION PROGRAM. HILLTOWN DAM (NDS ID NUMBER PA--ETC(U)

HILLTOWN DAM, BUCKS COUNTY  
PENNSYLVANIA

PHASE I INSPECTION REPORT,  
NATIONAL DAM INSPECTION PROGRAM

AUGUST 1980

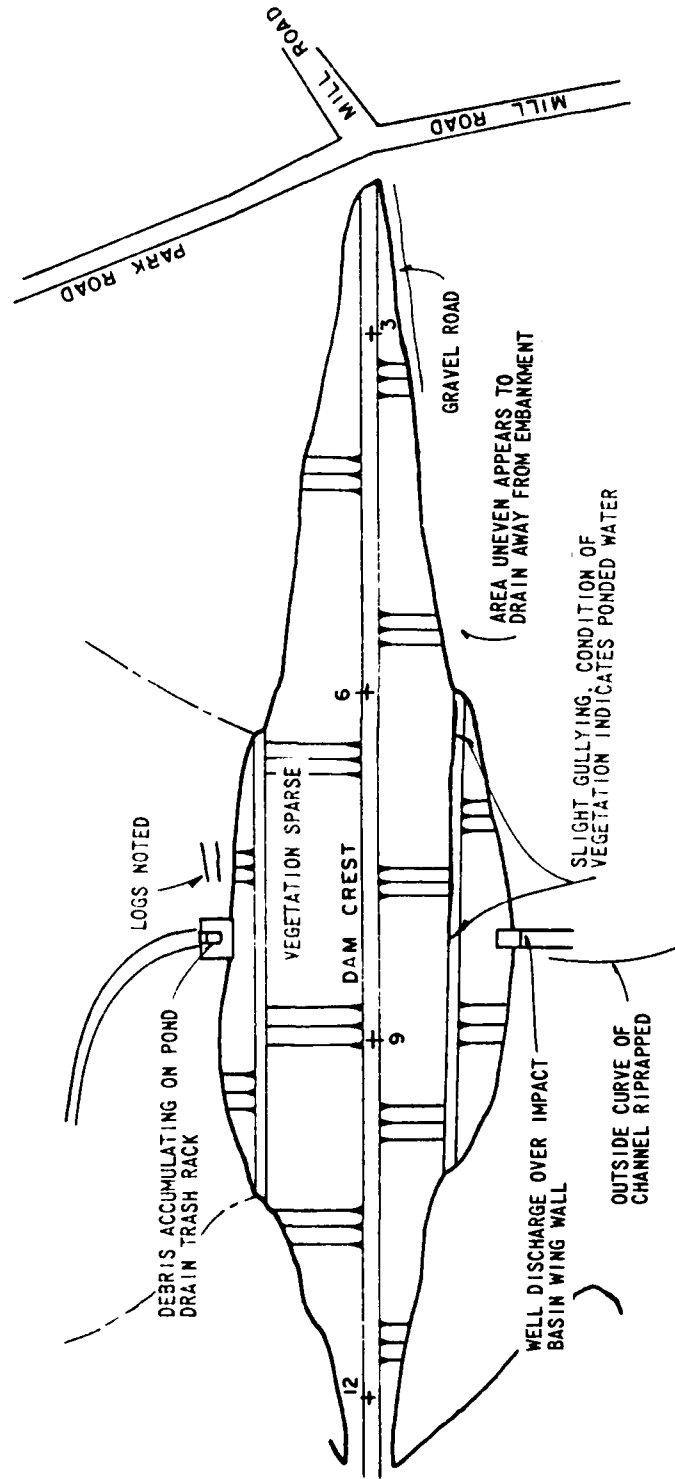
FIELD OBSERVATION PLAN  
 HILLTOWN DAM  
 (SCS PA 625)  
 SHEET 5A OF 11

VISUAL EXAMINATION OF VEGETATION	OBSERVATIONS	REMARKS OR RECOMMENDATIONS
	The upstream and downstream embankment faces, and emergency spillway were dormant seeded and mulched in 1979. Crownvetch is becoming established. Cover was good on downstream face and not quite as good on upstream face.	
JUNCTION OF EMBANKMENT AND ABUTMENT, SPILLWAY AND DAM	All junctions of embankment and abutments are in good condition.	
ANY NOTICEABLE SEEPAGE	None, reservoir was dry at time of inspection.	
STAFF GAGE AND RECORDER	None	
DRAINS	Embankment drains outletting through impact basin walls were dry. A flowing well uncovered during construction was piped and discharges over the impact basin wall. Moss on the rock indicates the well flows most, if not all of the time. Discharge was measured to be 0.43 gpm.

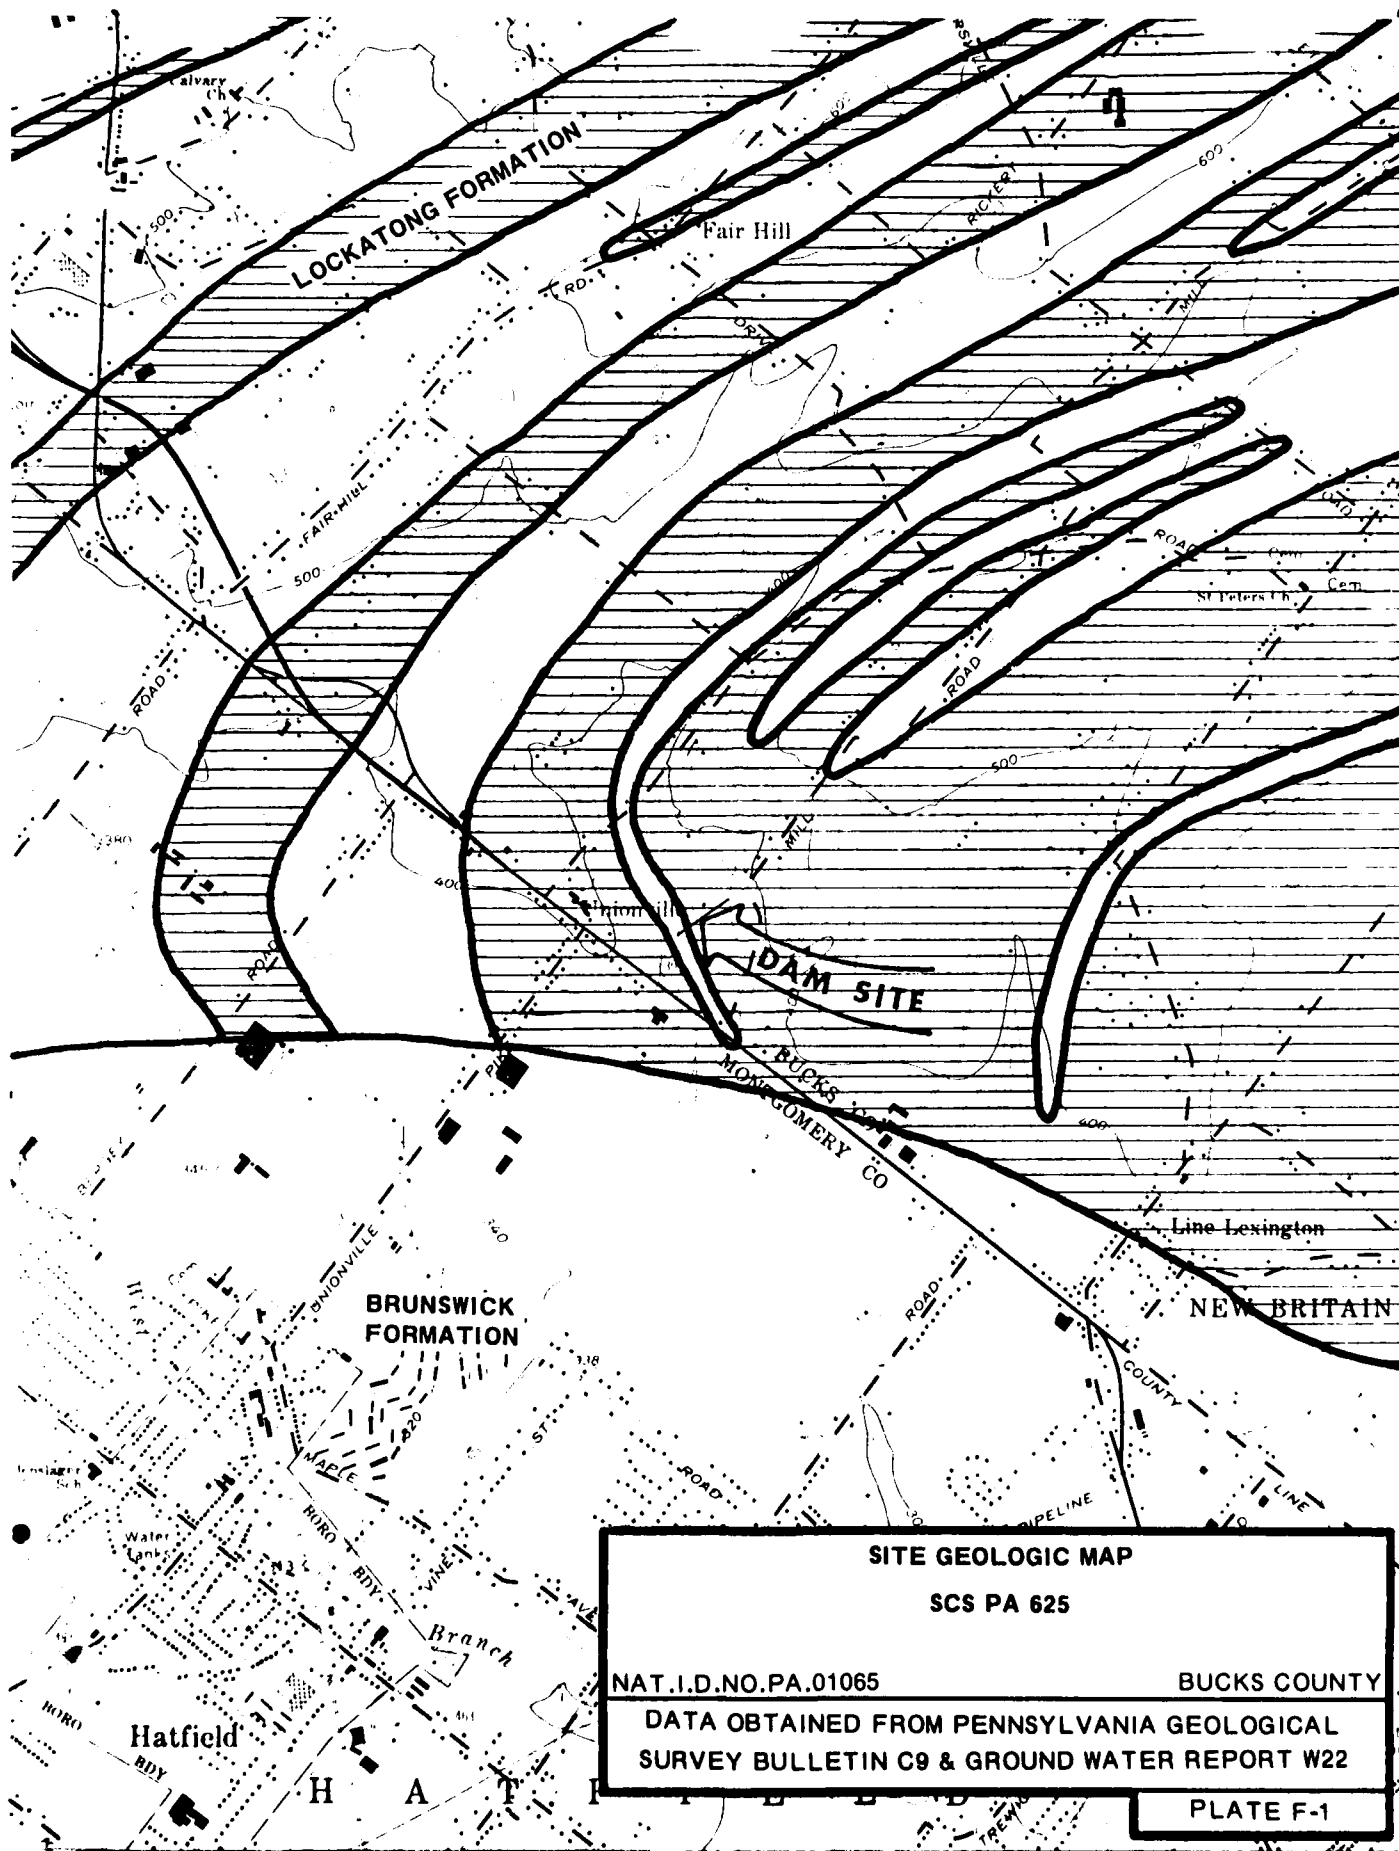
**SITE GEOLOGIC MAP**

SCS PA 625 Dam is located in the Triassic Lowland Section of the Piedmont Physiographic Province. As shown in Plate F-1, the dam is underlain by the Lockatong Formation of Triassic age and to a lesser extent to the Brunswick Formation also of Triassic age. Bedrock descriptions in the state files include fractured red shale, siltstone and argillite (compact, fine grained sedimentary rock) which is consistent with observed bedrock exposures in the emergency spillway. Bedding reportedly strikes from N10°W to N20°E dipping from 30 to 35 degrees west (toward the right abutment). Rock jointing reportedly strikes N40°E to N55°E and N50°W. As indicated in the as-built drawings, the cutoff trench is entirely founded into bedrock.

Approximately 1,500 feet south of the dam is a regional east-west striking fault which extends across Montgomery and Bucks Counties for over 20 miles.
